**Region 6 Compliance Assurance and Enforcement Division
INSPECTION REPORT**

Inspection Date(s):		04/15-17/2014	
Media:		Water	
Regulatory Program(s)		NPDES - CAFO	
Company Name:		C & H Hog Farms, Inc.	
Facility Name:		C & H Hog Farm, Inc.	
Facility Physical Location:		HC 72 Box 2	
(city, state, zip code)		Vendor, AR 72683	
Mailing address:		HC 72 Box 2	
(city, state, zip code)		Vendor, AR 72683	
County/Parish:		Newton	
Facility Contact:		Jason Henson	President
		chhogfarmsinc@yahoo.com	
FRS Number:		N/A	
Identification/Permit Number:		ARG590001	
Media Number:		N/A	
NAICS:		112210	
SIC:		0213	
Facility Representatives:		Jason Henson	President 870 688-1318
EPA Inspectors:		Carl Wills	6EN-WR 214 665-7276
		Chris Lister	6EN-WR 214 665-6672
State Inspector(s):		Jason Bolenbaugh	ADEQ Inspection Branch Manager 501 682-0659
Other Inspector(s):		None	
Metadata	Title:	C & H Hog Farms Judea Newton County Arkansas	
	Author:	US EPA Region 6 Compliance Assurance and Enforcement Division Dallas TX	
	Subject:	CAFO Inspection Report

Keywords:	CAFO Clean Water Act, Compliance Evaluation	
EPA Lead Inspector Signature/Date		Carl Wills {Inspector name}	 Date 06/12/2014
Supervisor Signature/Date		Wil

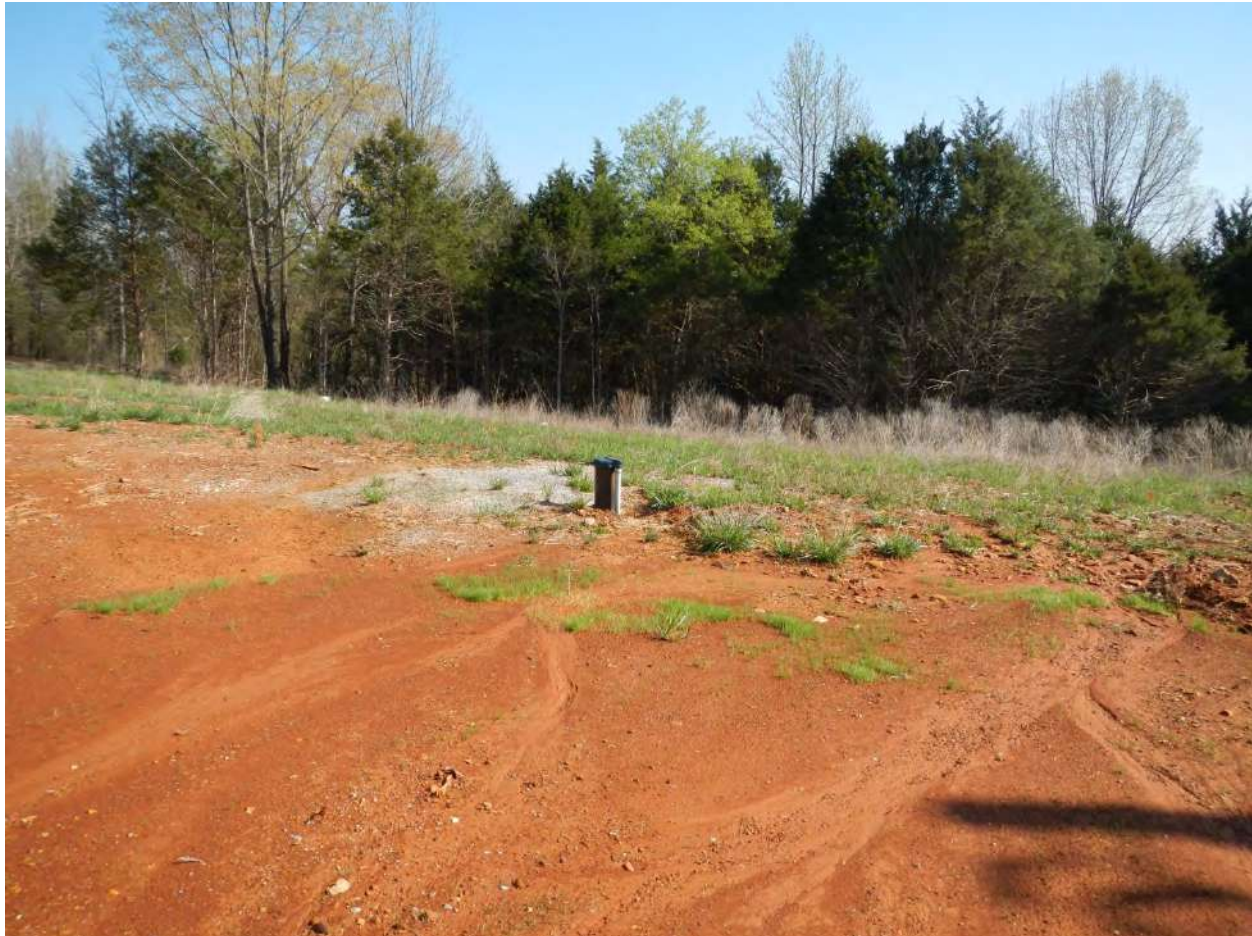
Photo No. 1

Description: View to the north of the water supply well. The well has a total depth of 320 feet with the depth of water being at approximately 280 feet.

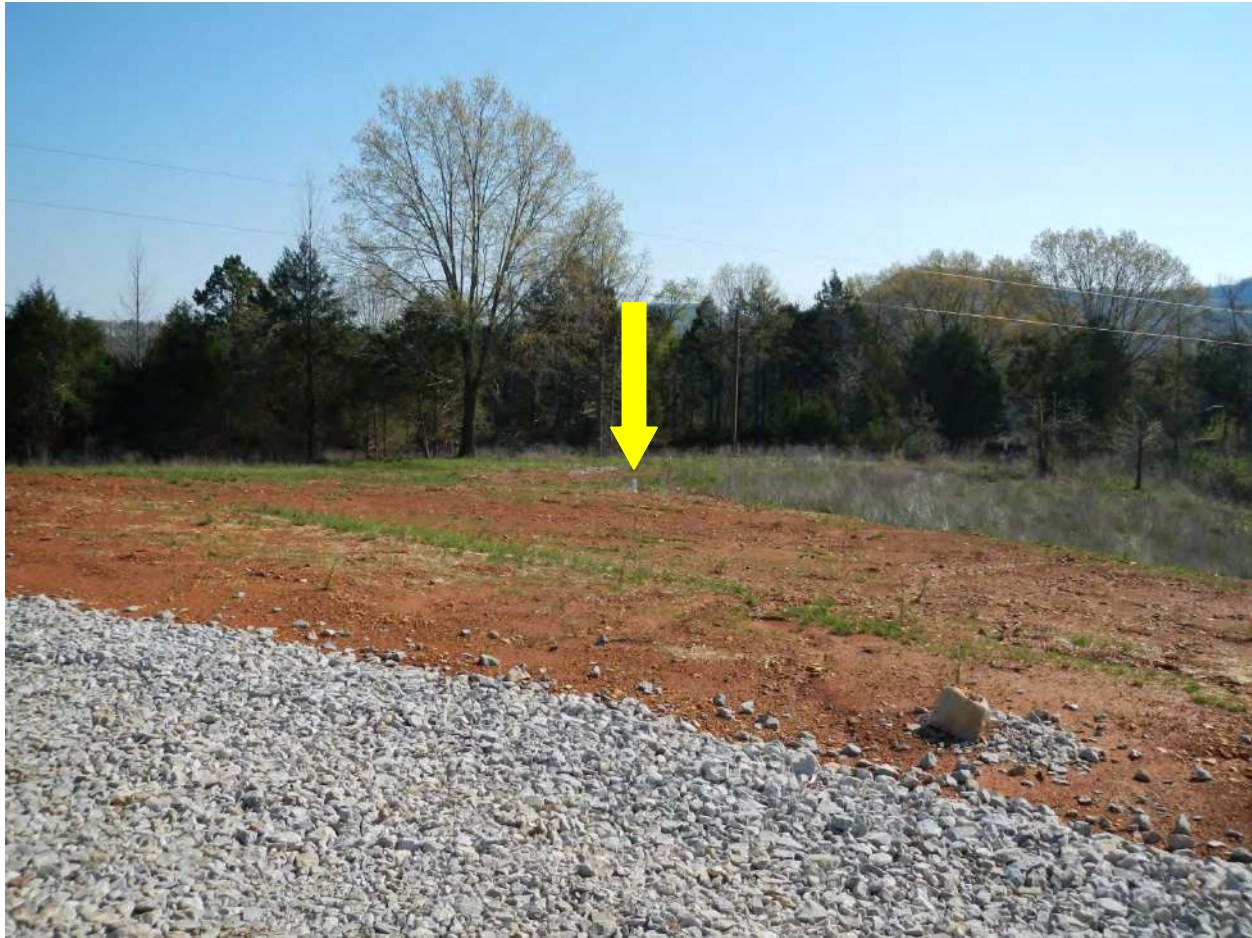
Photo No. 2

Description: View to the northeast of the cleanout (white riser in the center of the photograph) for human septage with the leachfield north of the cleanout.

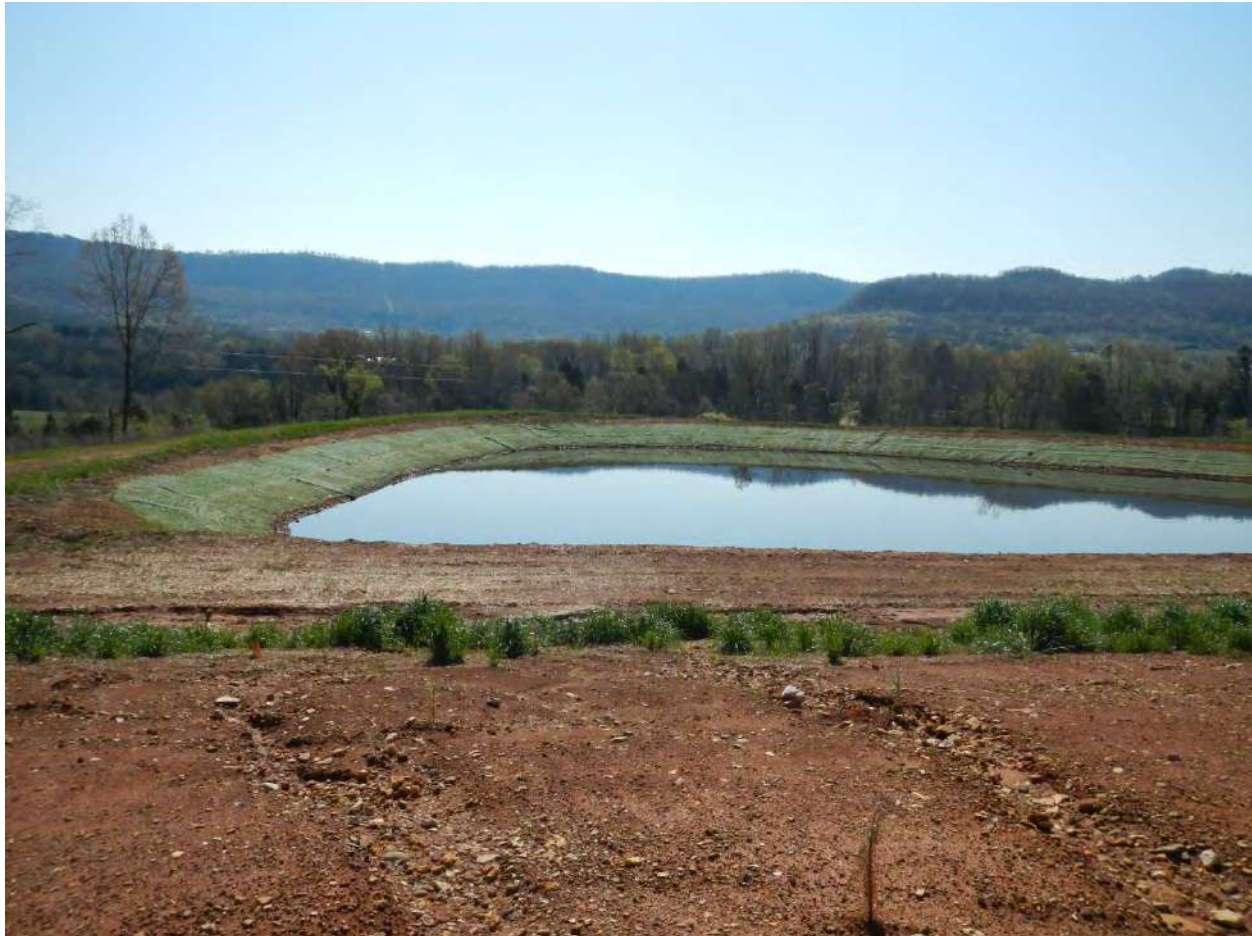
Photo No. 3

The physical site inspection showed that the waste holding ponds were in good condition. Turf reinforcement mats were recently installed on the inside of the two waste holding ponds. This has been done to attempt to establish vegetative cover and control any erosion. The holding pond had adequate

Description: View to the east of the secondary lagoon with geotextile fabric in place, to aid in soil stabilization.

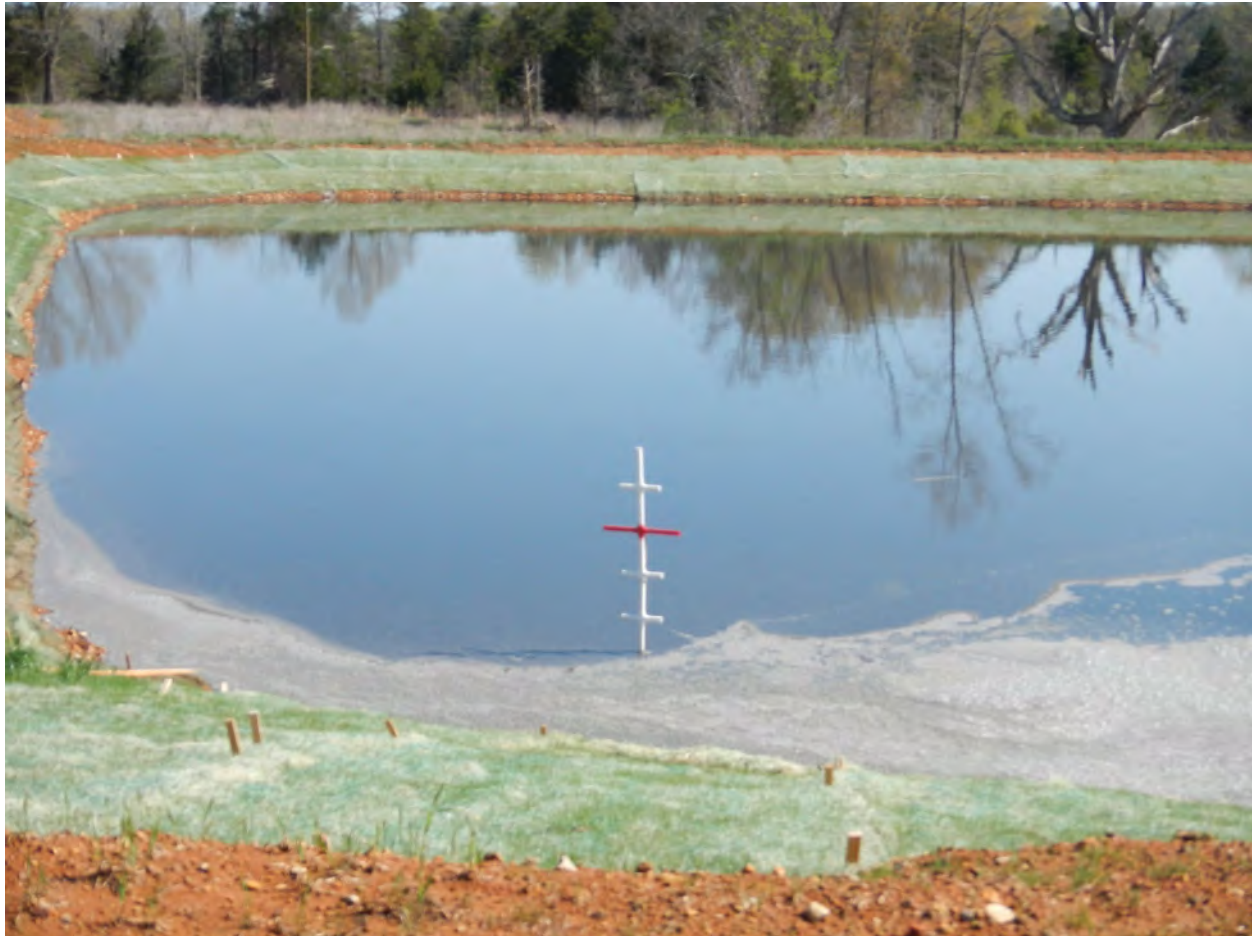
Photo No. 4

Description: View to the north-northeast of the staff gauge in the secondary lagoon – operator needs to extend the top of the gauge to show the lowest point of the lagoon berm, so that they will know when the effluent will overtop the berm.

No follow-up with this facility is anticipated. However, we would recommend that the splash plate on back of the vacuum truck applicator be changed to a spray bar with multiple nozzles in order to provide more even application of effluent. Also the turf reinforcement mats need to be resealed in spots in the primary waste holding pond. The staff gauge in the secondary waste holding pond should to be lengthened in order to define the level at which the contents would actually over top the structure.

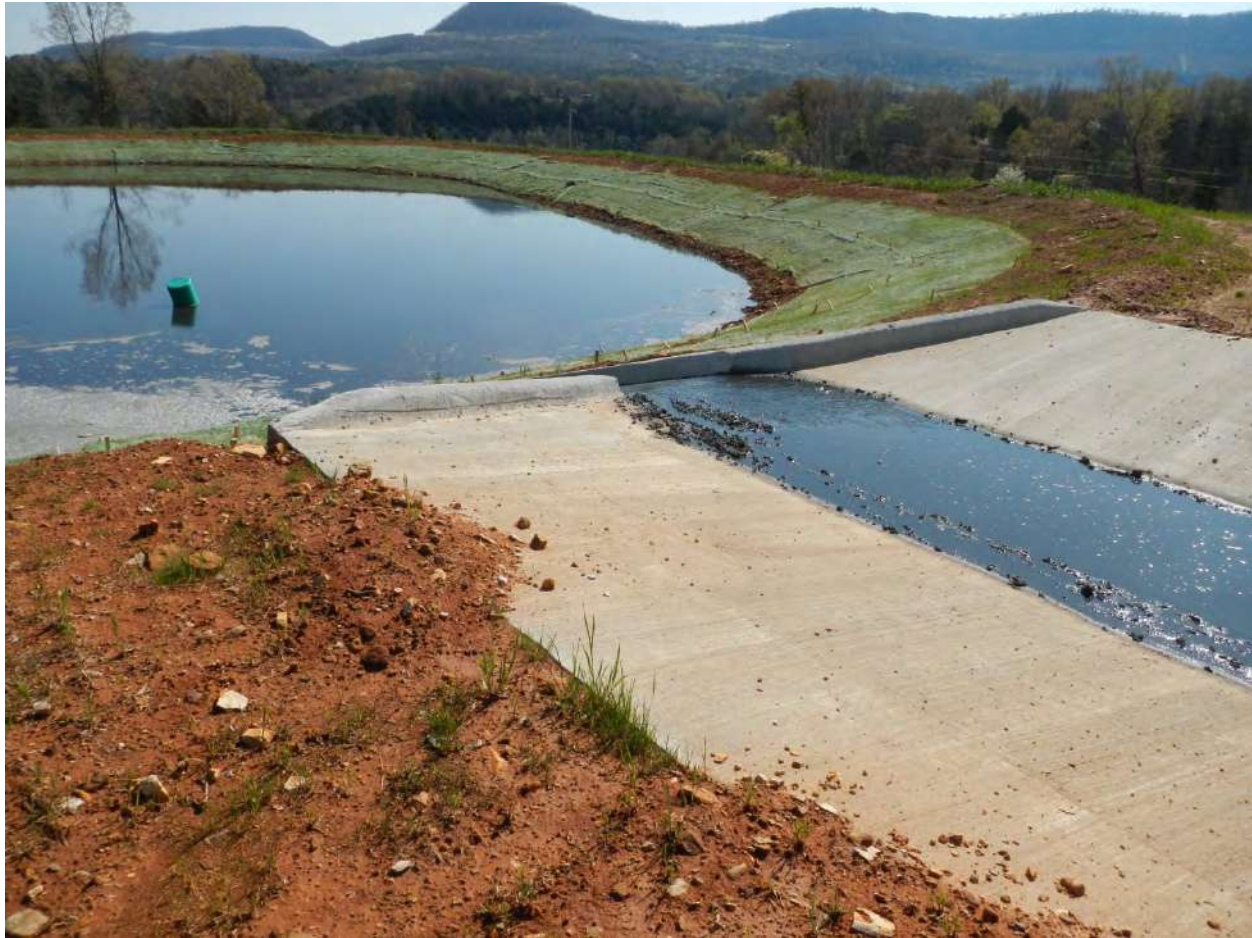
Photo No. 5

Description: View to the northeast of the concrete spillway entering the secondary lagoon and that the barns' flushwater is pumped from the area below the floating blue/green drum.

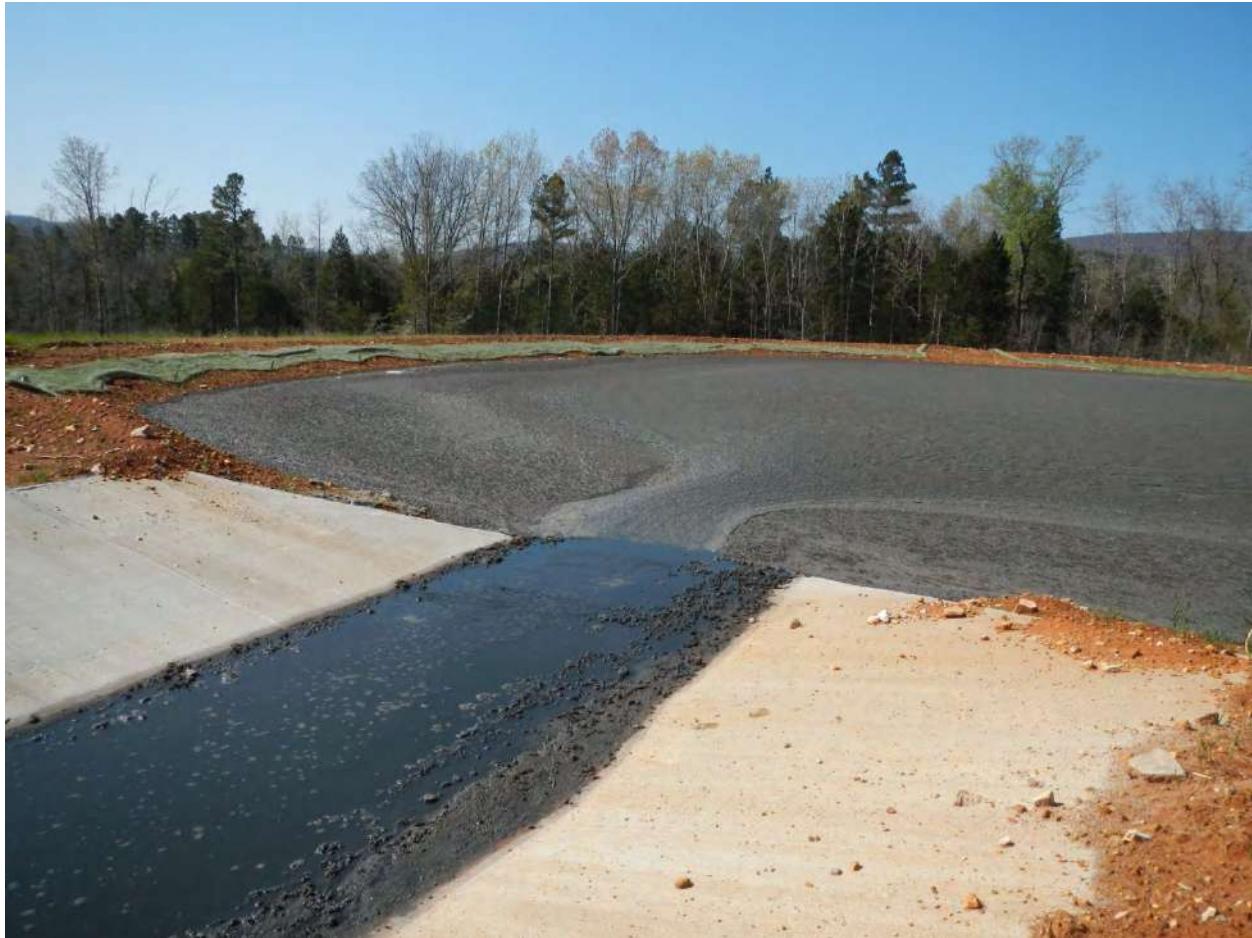
Photo No. 6

Description: View to the south of the primary lagoon and concrete spillway (flow is toward the photographer). The geotextile fabric placed on the primary lagoon's interior berm slopes, for soil stabilization, needs re-anchoring around the perimeter.

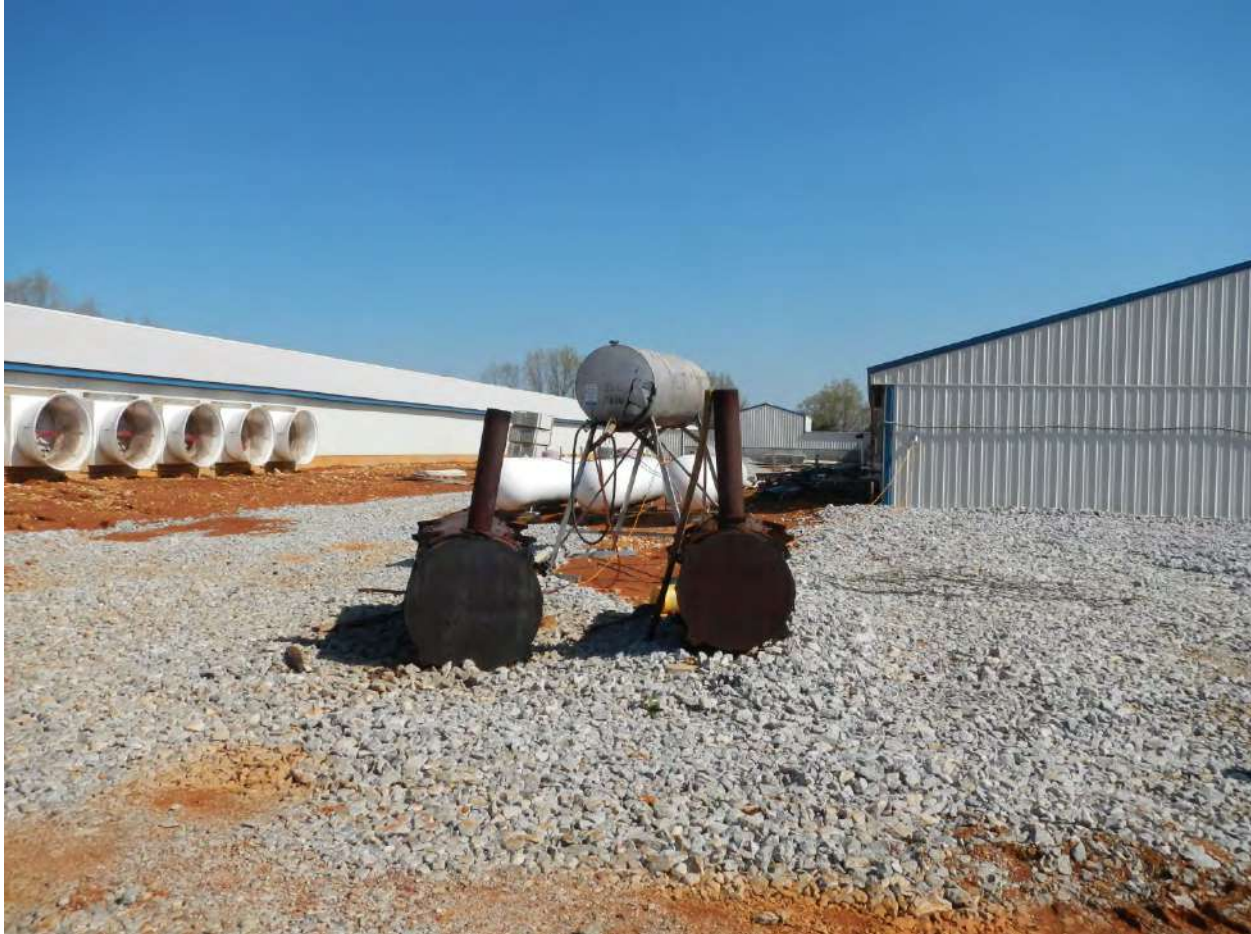
Photo No. 7

Description: View to the north of the two diesel fired incinerators between the south ends of the two barns. There is no evidence that either of the units has had any problems with improperly incinerated mortalities.

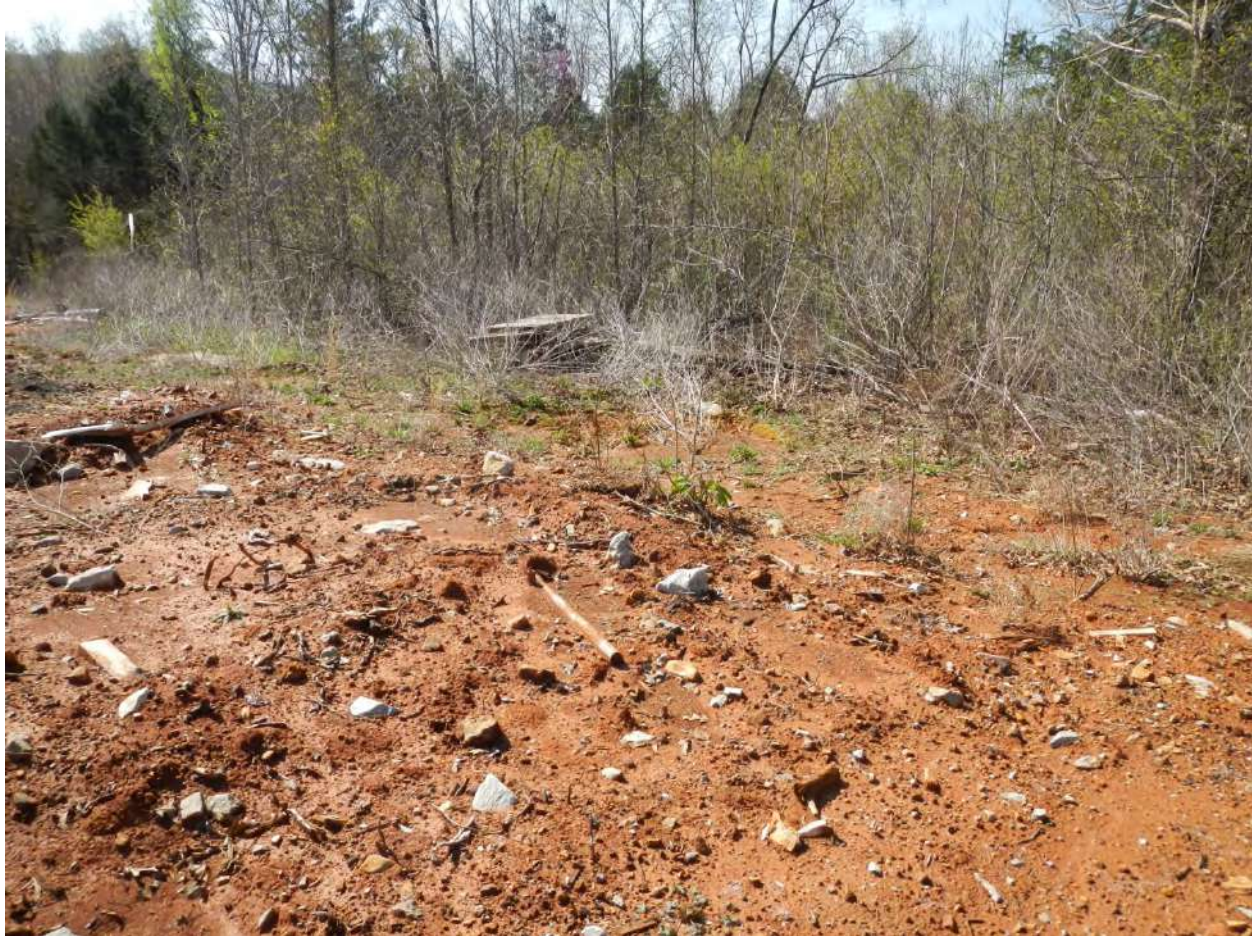
Photo No. 8

Description: View to the southeast of the area where the ashes of incinerated mortalities are buried.

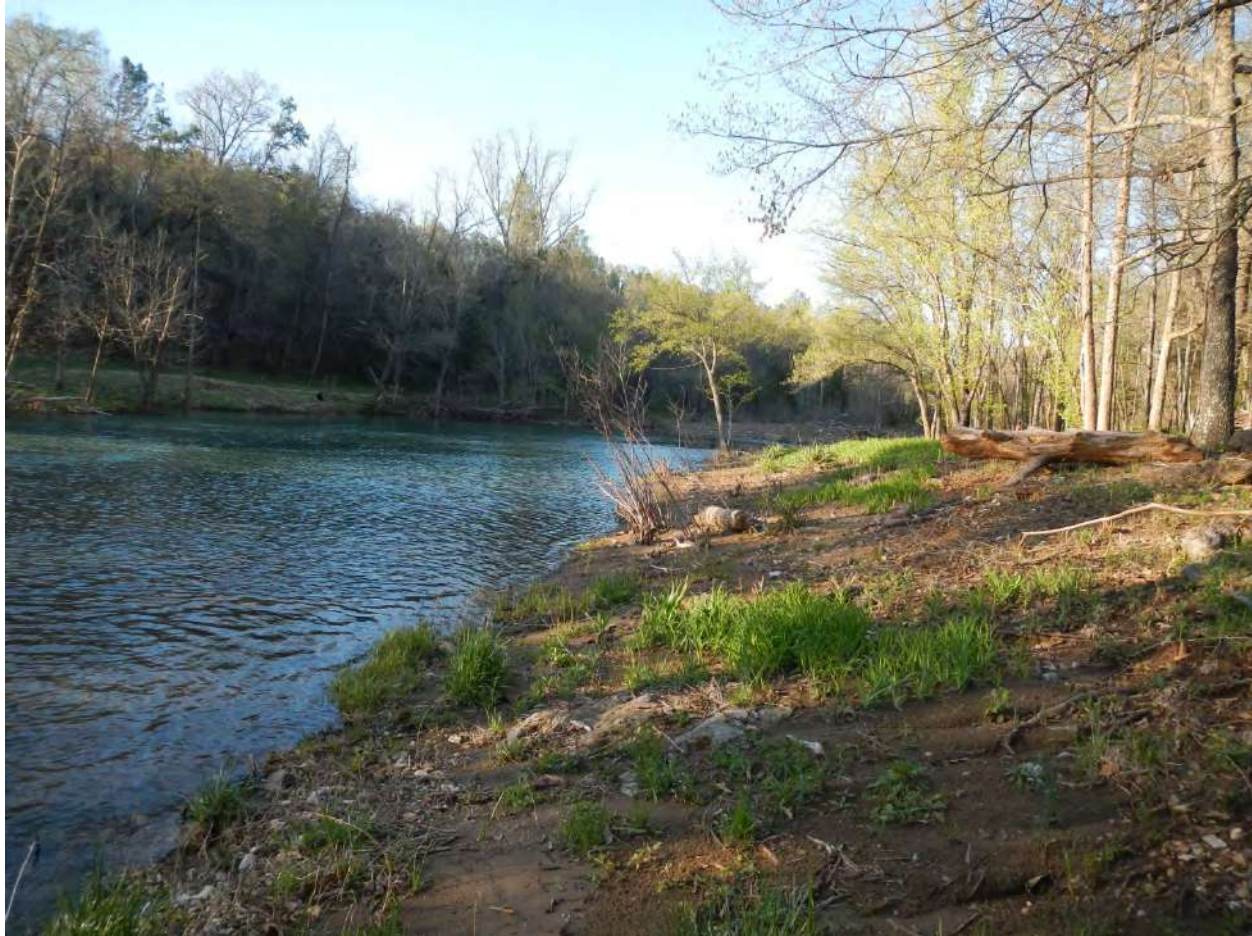
Photo No. 10

Description: View to the north of Big Creek (downstream), where WS-1 was collected (@ 09:15 on 04/16/2014).

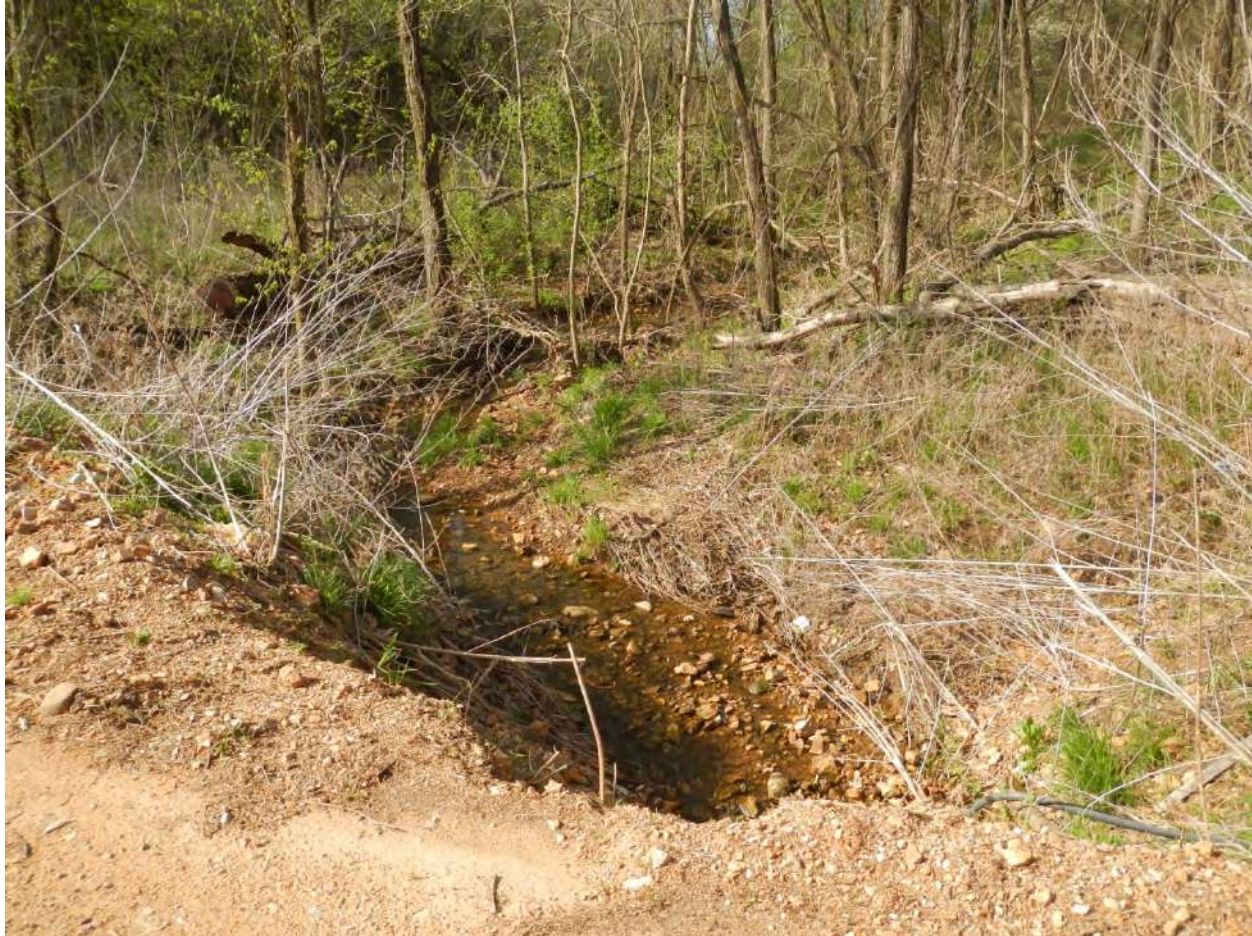
Photo No. 11

Water samples (Photos 9 – 33) were collected from various streams up-gradient and down-gradient of the facility. Samples were analyzed for E. coli, 5-day BOD (Environmental Services Company, Inc., Springdale, AR), cations, anions, EC, NH₄-N, ICAP-P and other analytes (Oklahoma State University Soil, Water & Forage Analytical Laboratory). The facility had 1.1 inches of rain on April 13 and as a result most of the small streams did have flowing water at the time of the inspection. Results and a map of the sample locations can be found in Appendix 2.

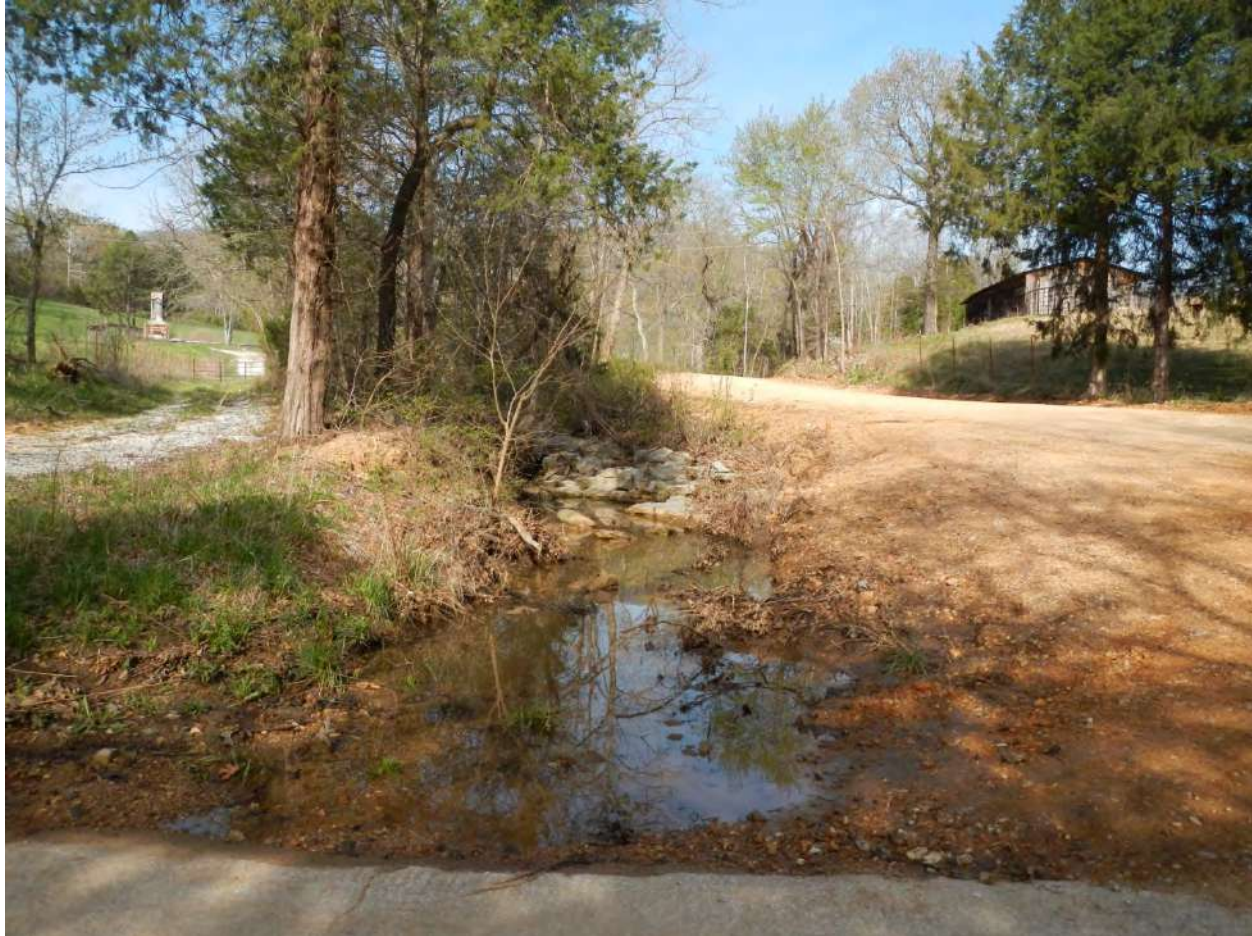
Photo No. 13

Description: View to the west (upstream), where WS-3 was collected (@ 10:03 on 04/16/2014 at which time, water was flowing over the concrete at this low water crossing).

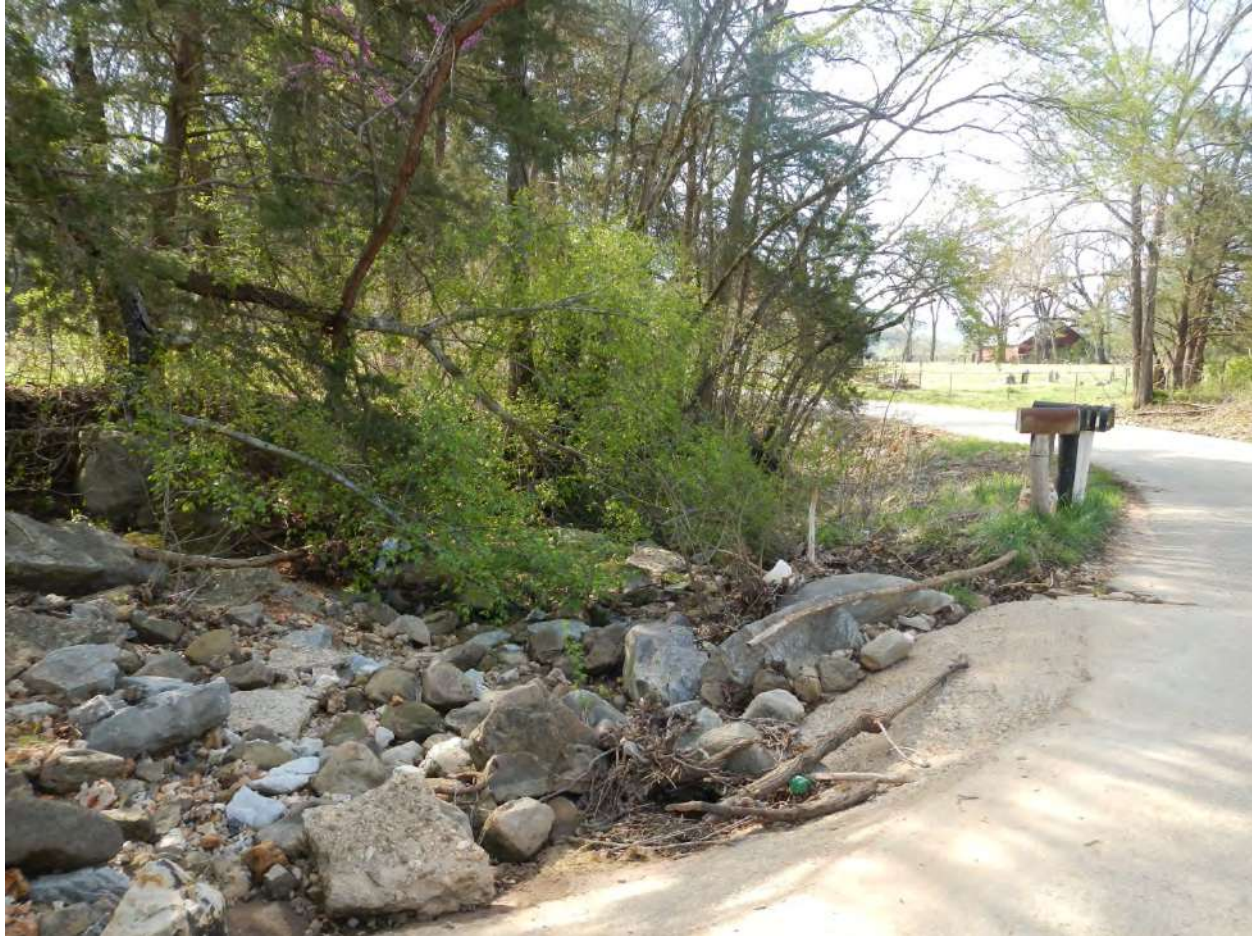
Photo No. 14

Description: View to the southeast (downstream), where WS-3 was collected (@ 10:03 on 04/16/2014 at which time, water was flowing over the concrete at this low water crossing).

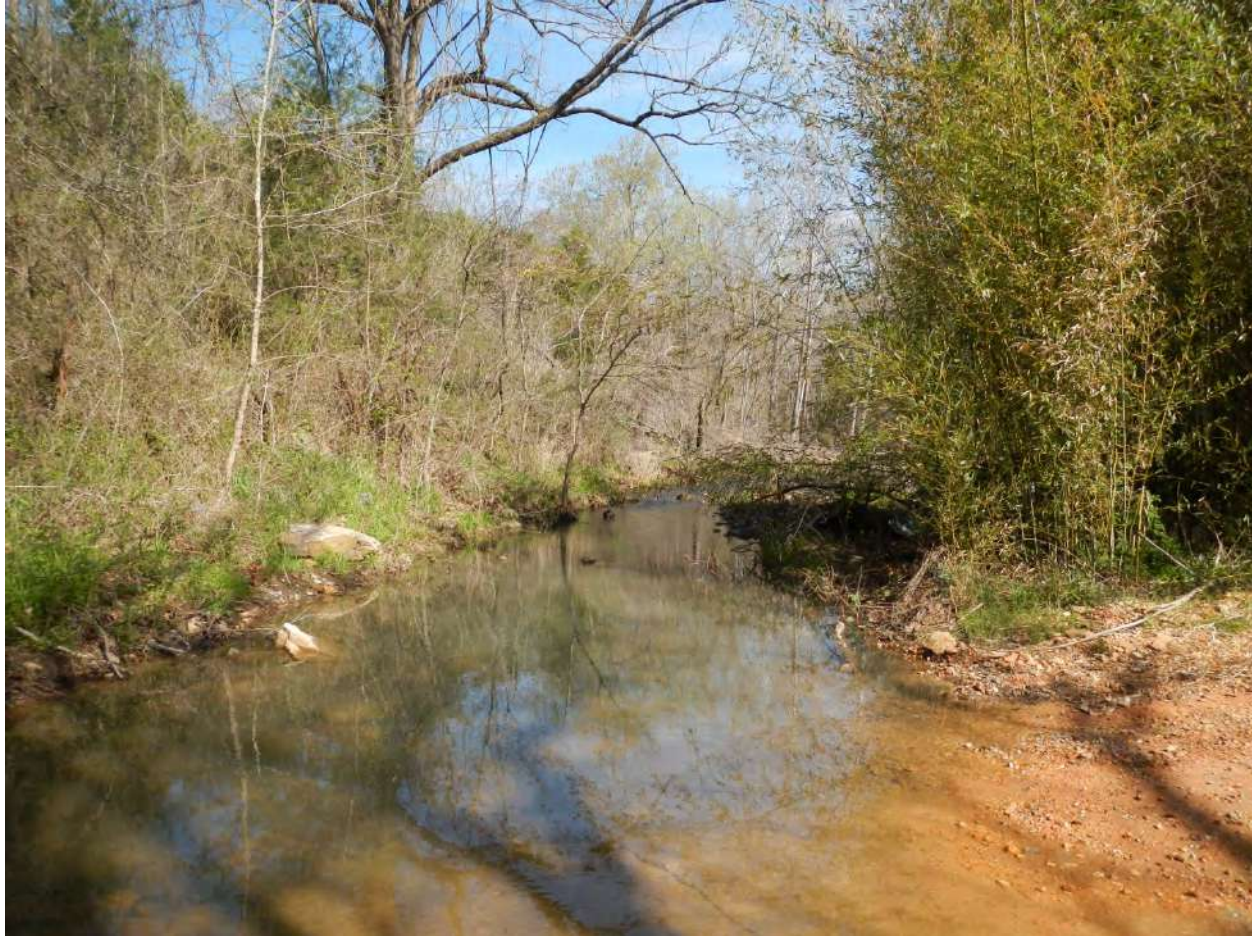
Photo No. 17

Description: View to the northwest (upstream), where WS-5 was collected (@ 10:34 on 04/16/2014).

This is a concrete low water crossing with the photographer standing in the middle of the road.
